Manhole Inspection Summary

Manhole # S25E__019MH

Insp Date: **8/7/07 8:56 AM**

Location Address: **1145 SARATOGA ST**

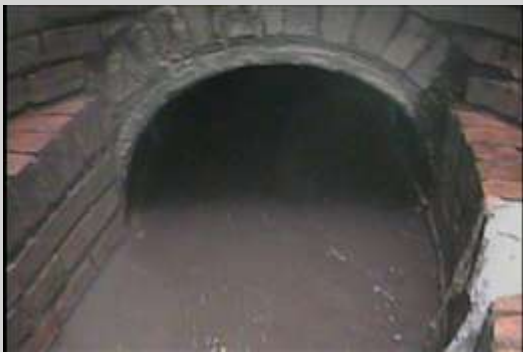
12 O'Clock Outflow

21 in. Circular Gravity Sewer
Pipe Out @ 12 O'Clock

Pipe Height: **22.8** (in.) Rod and Bar (Angled)
Pipe Material: **Clay** ☐ Pipe Lined
Invert Depth: **12.81** (ft.) Flow Characteristics: **Slow**
Deposits: ☒ None ☐ Mud ☐ Sludge ☐ Debris ☐ Grease
Silt Depth: (in.) Deposits Extent:
Infiltration: **None** Pipe Seal Cond: **Sound**

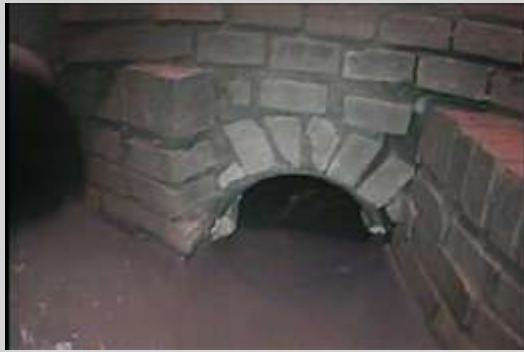
8 O'Clock Inflow

10 in. Circular Gravity Sewer

Pipe In @ 8 O'Clock

Pipe Height: **9.6** (in.) Rod and Bar (Angled)

Infiltration: **None** Pipe Seal Cond: **Sound**
